Effects of bank vegetation in waterways with special reference to bank erosion, shear strength, root density and channel hydraulics

**Effects of Bank Vegetation in Waterways with Special
Reference to Bank Erosion, Shear Strength, Root Density and
Channel Hydraulics**

**A thesis submitted to the Open University
for the Degree of Doctor of Philosophy
Biology Department
September 1992**

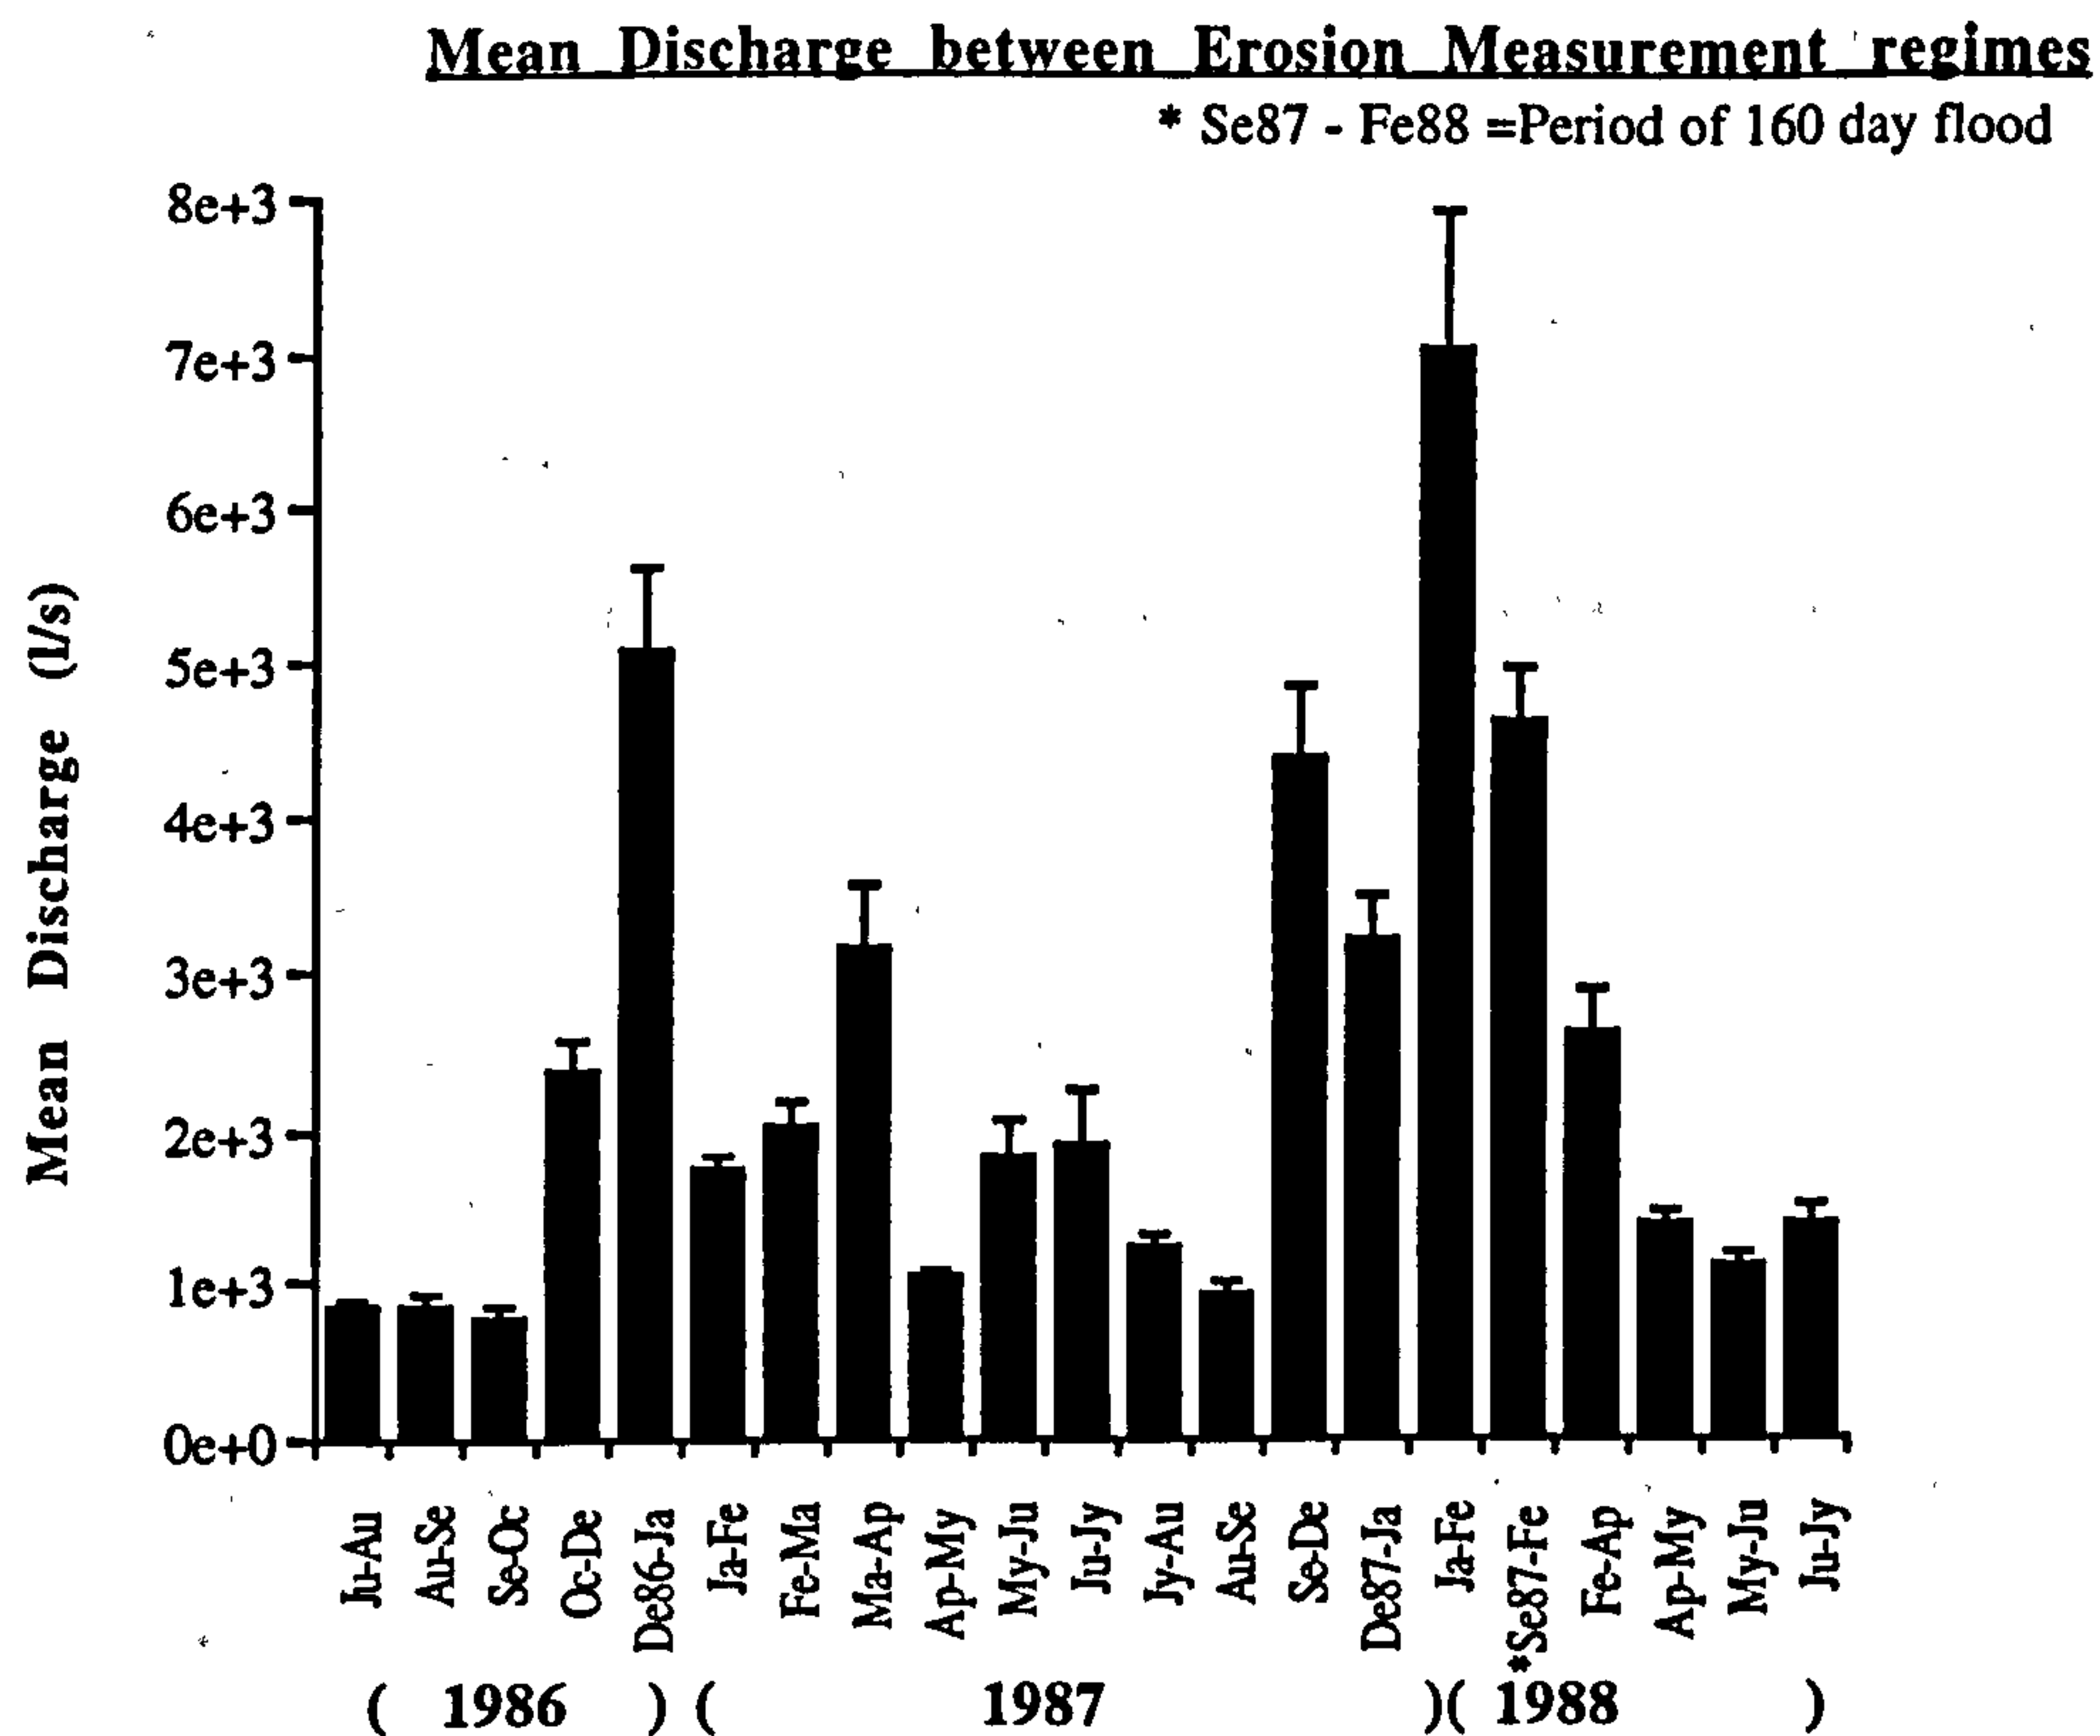
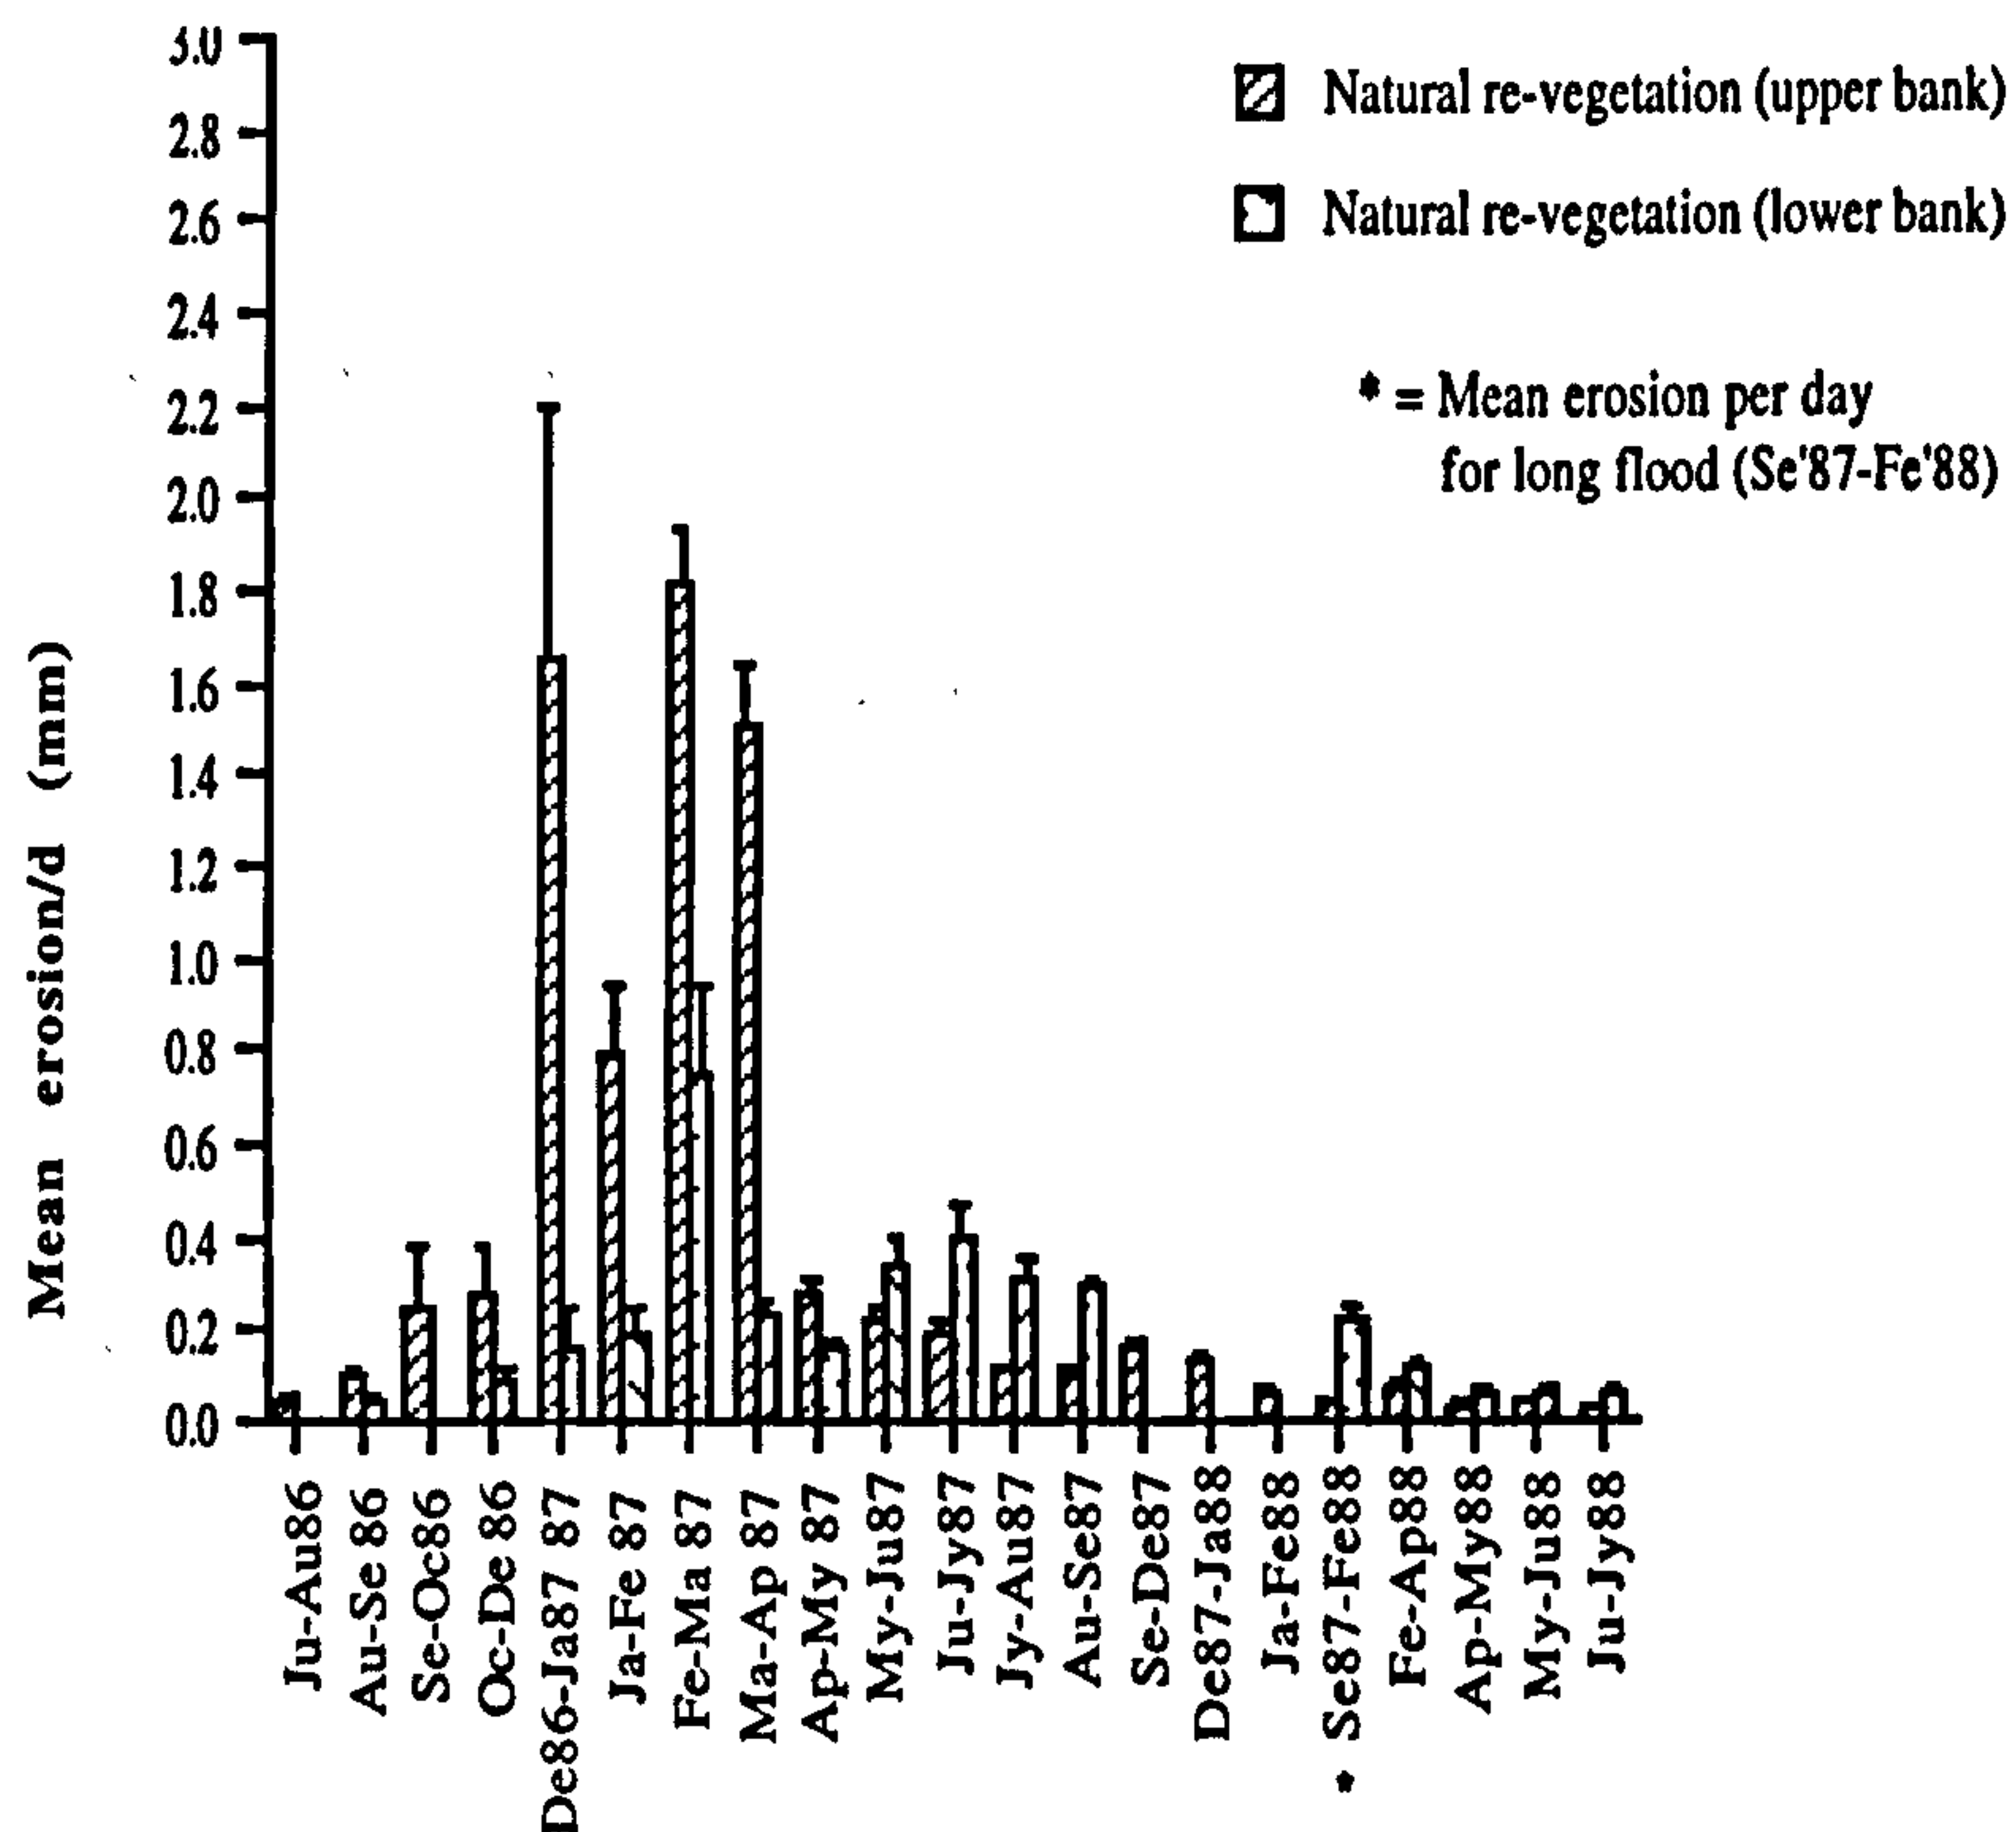
Fig. 5.4 : Comparison of erosion : Upper Vs. Lower banks within Naturally re-vegetated banks

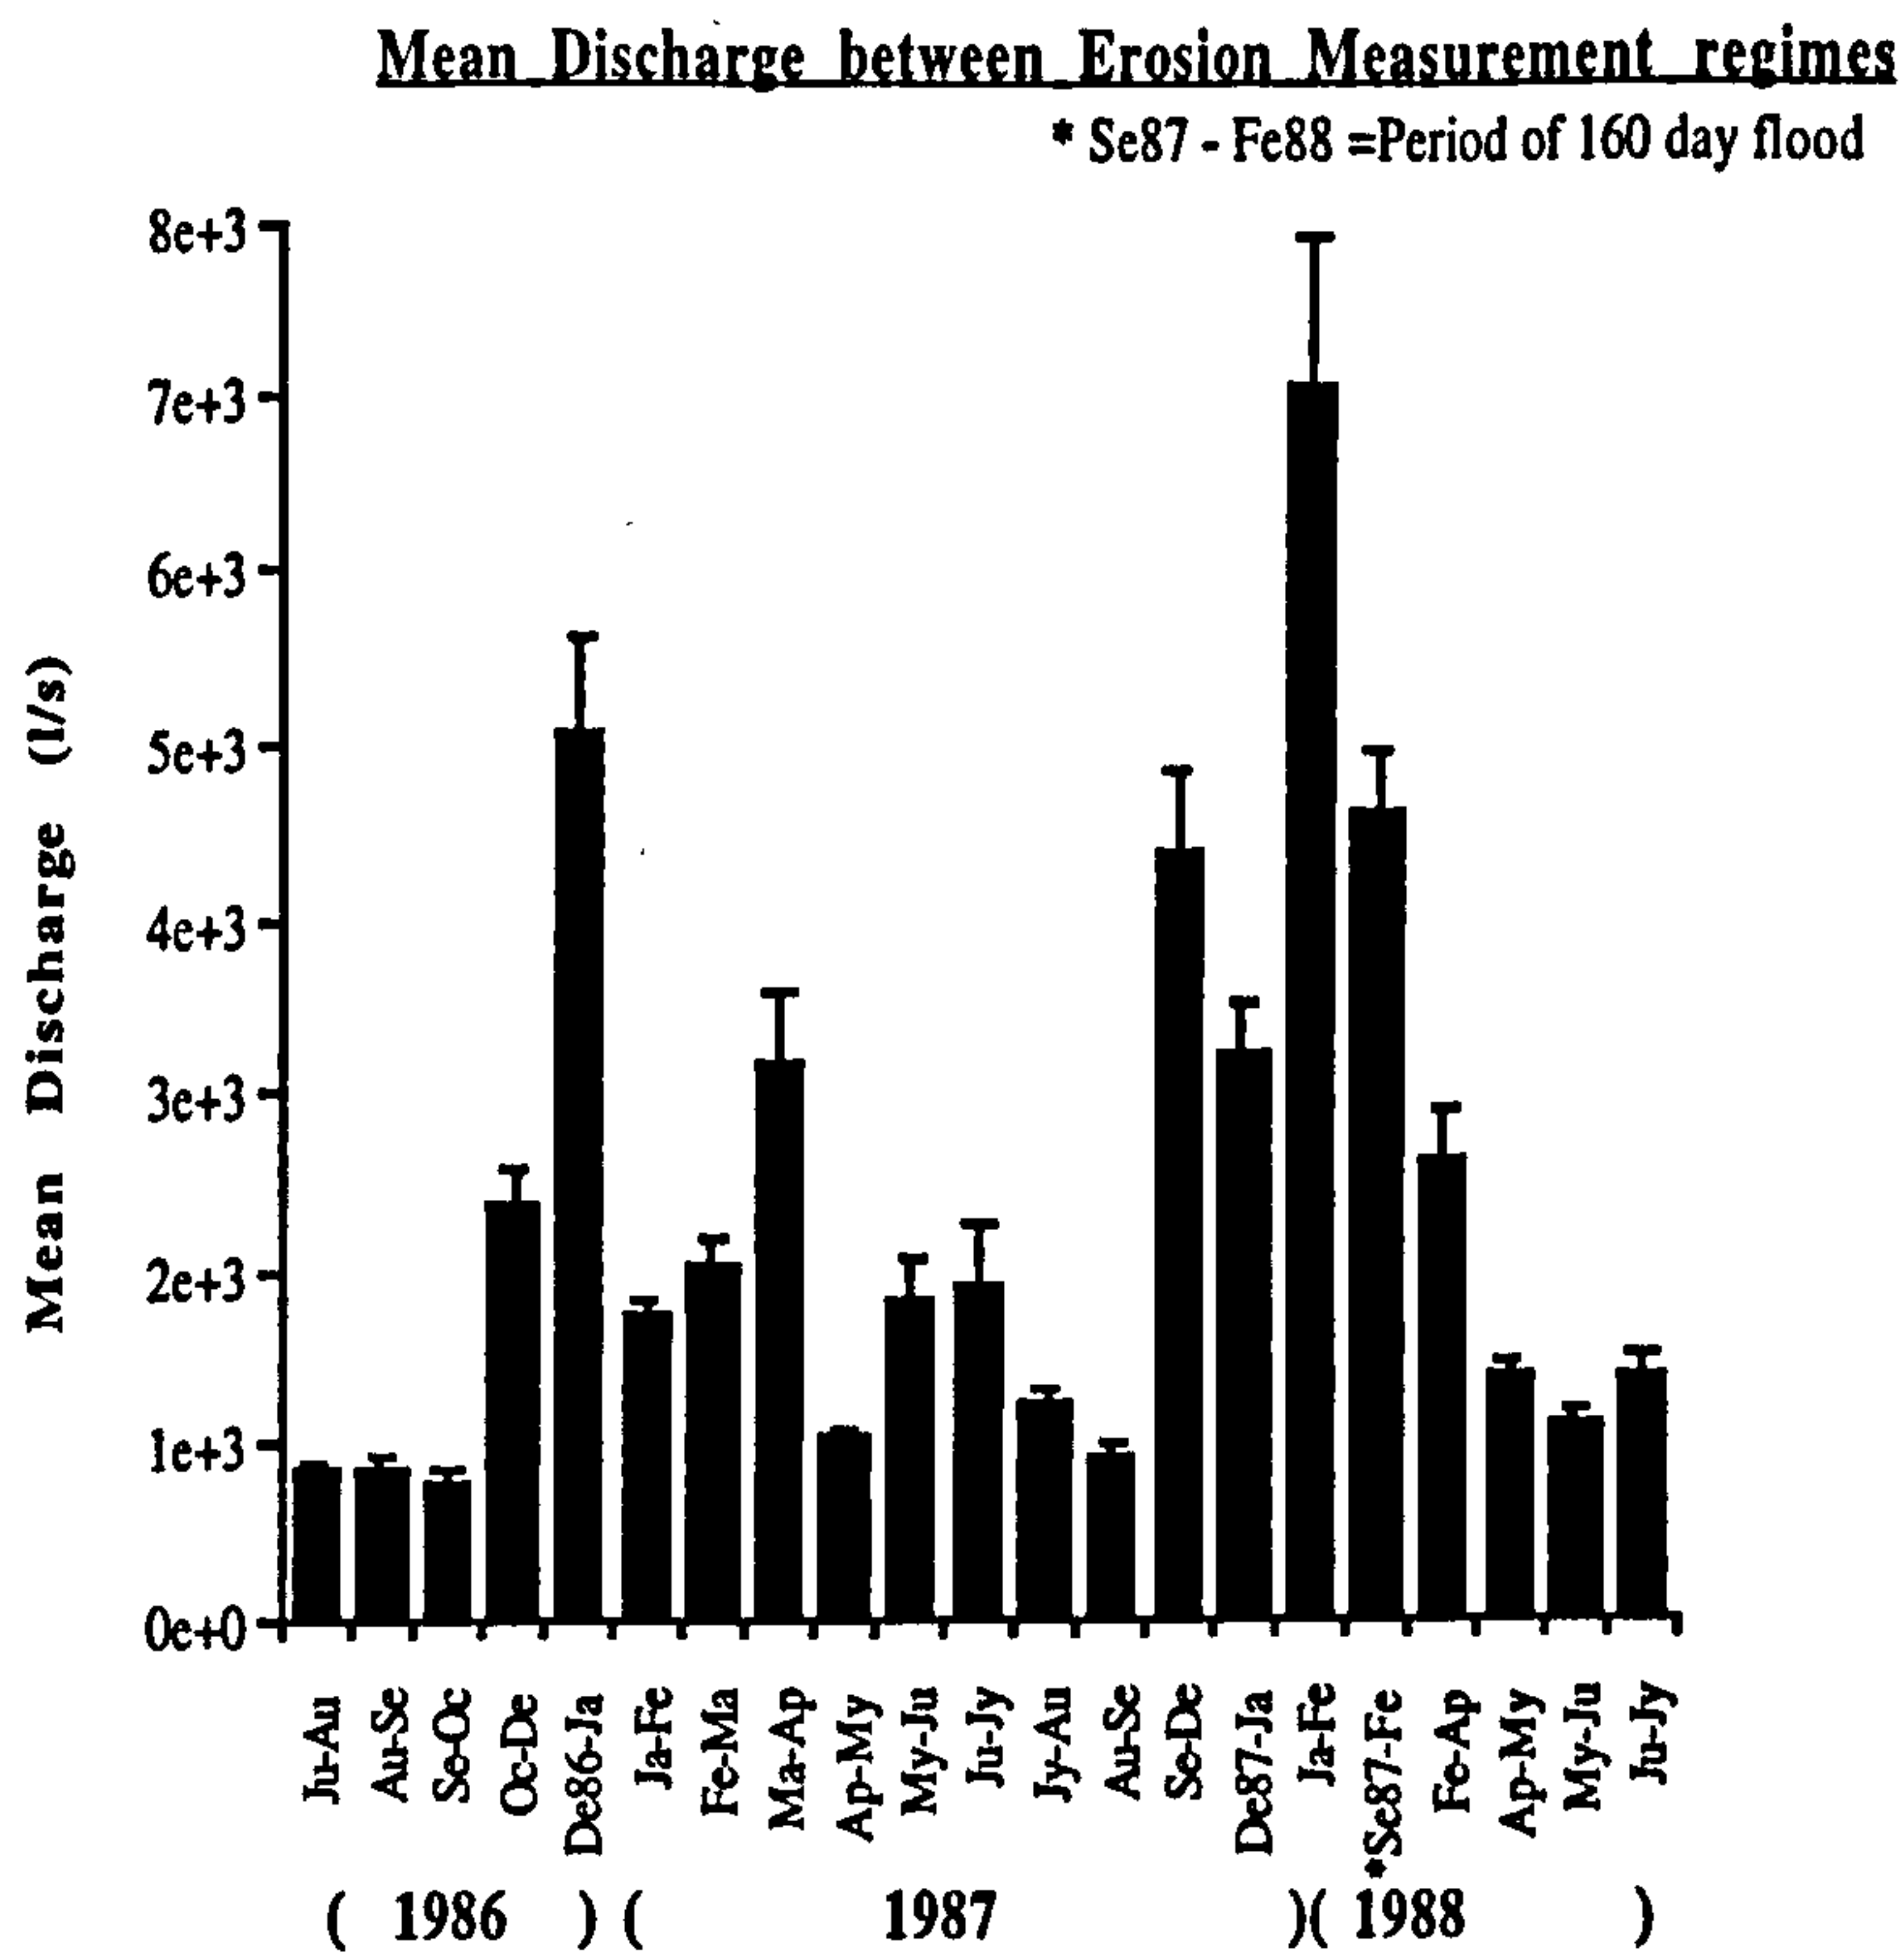
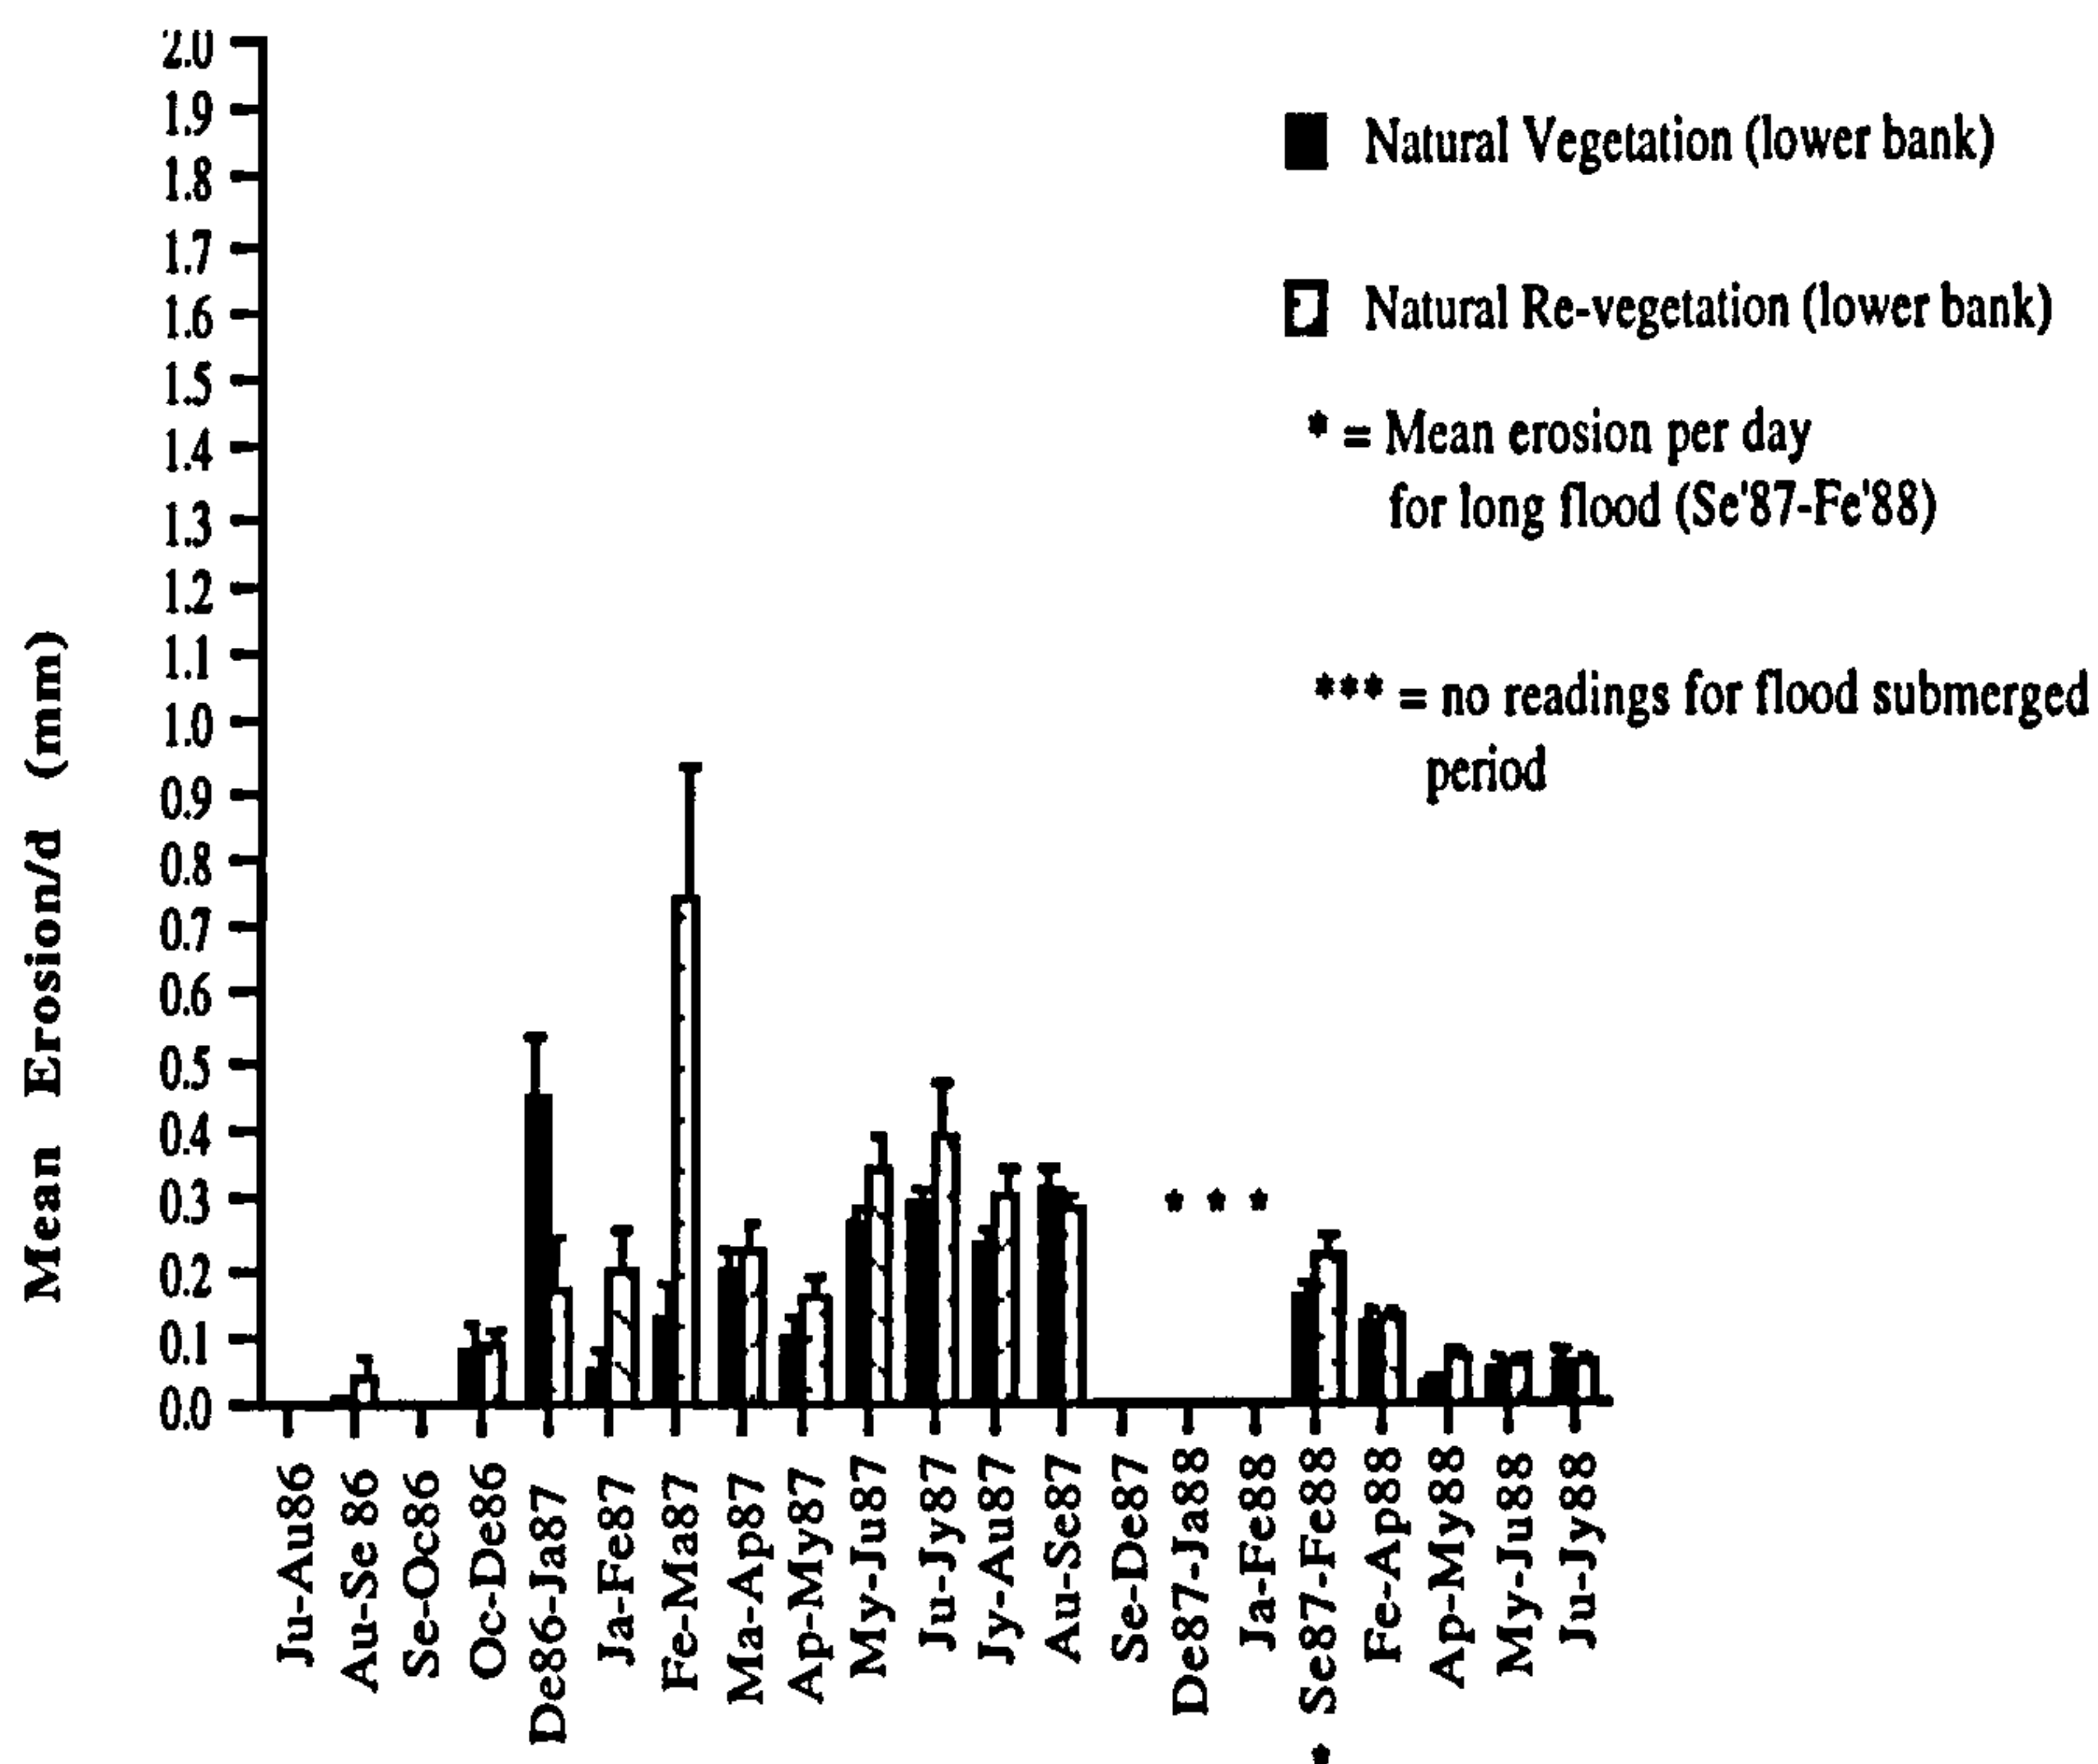
Fig.5.7 : Comparison of Erosion: Natural Vegetation Vs. Natural re-vegetation; (lower banks)

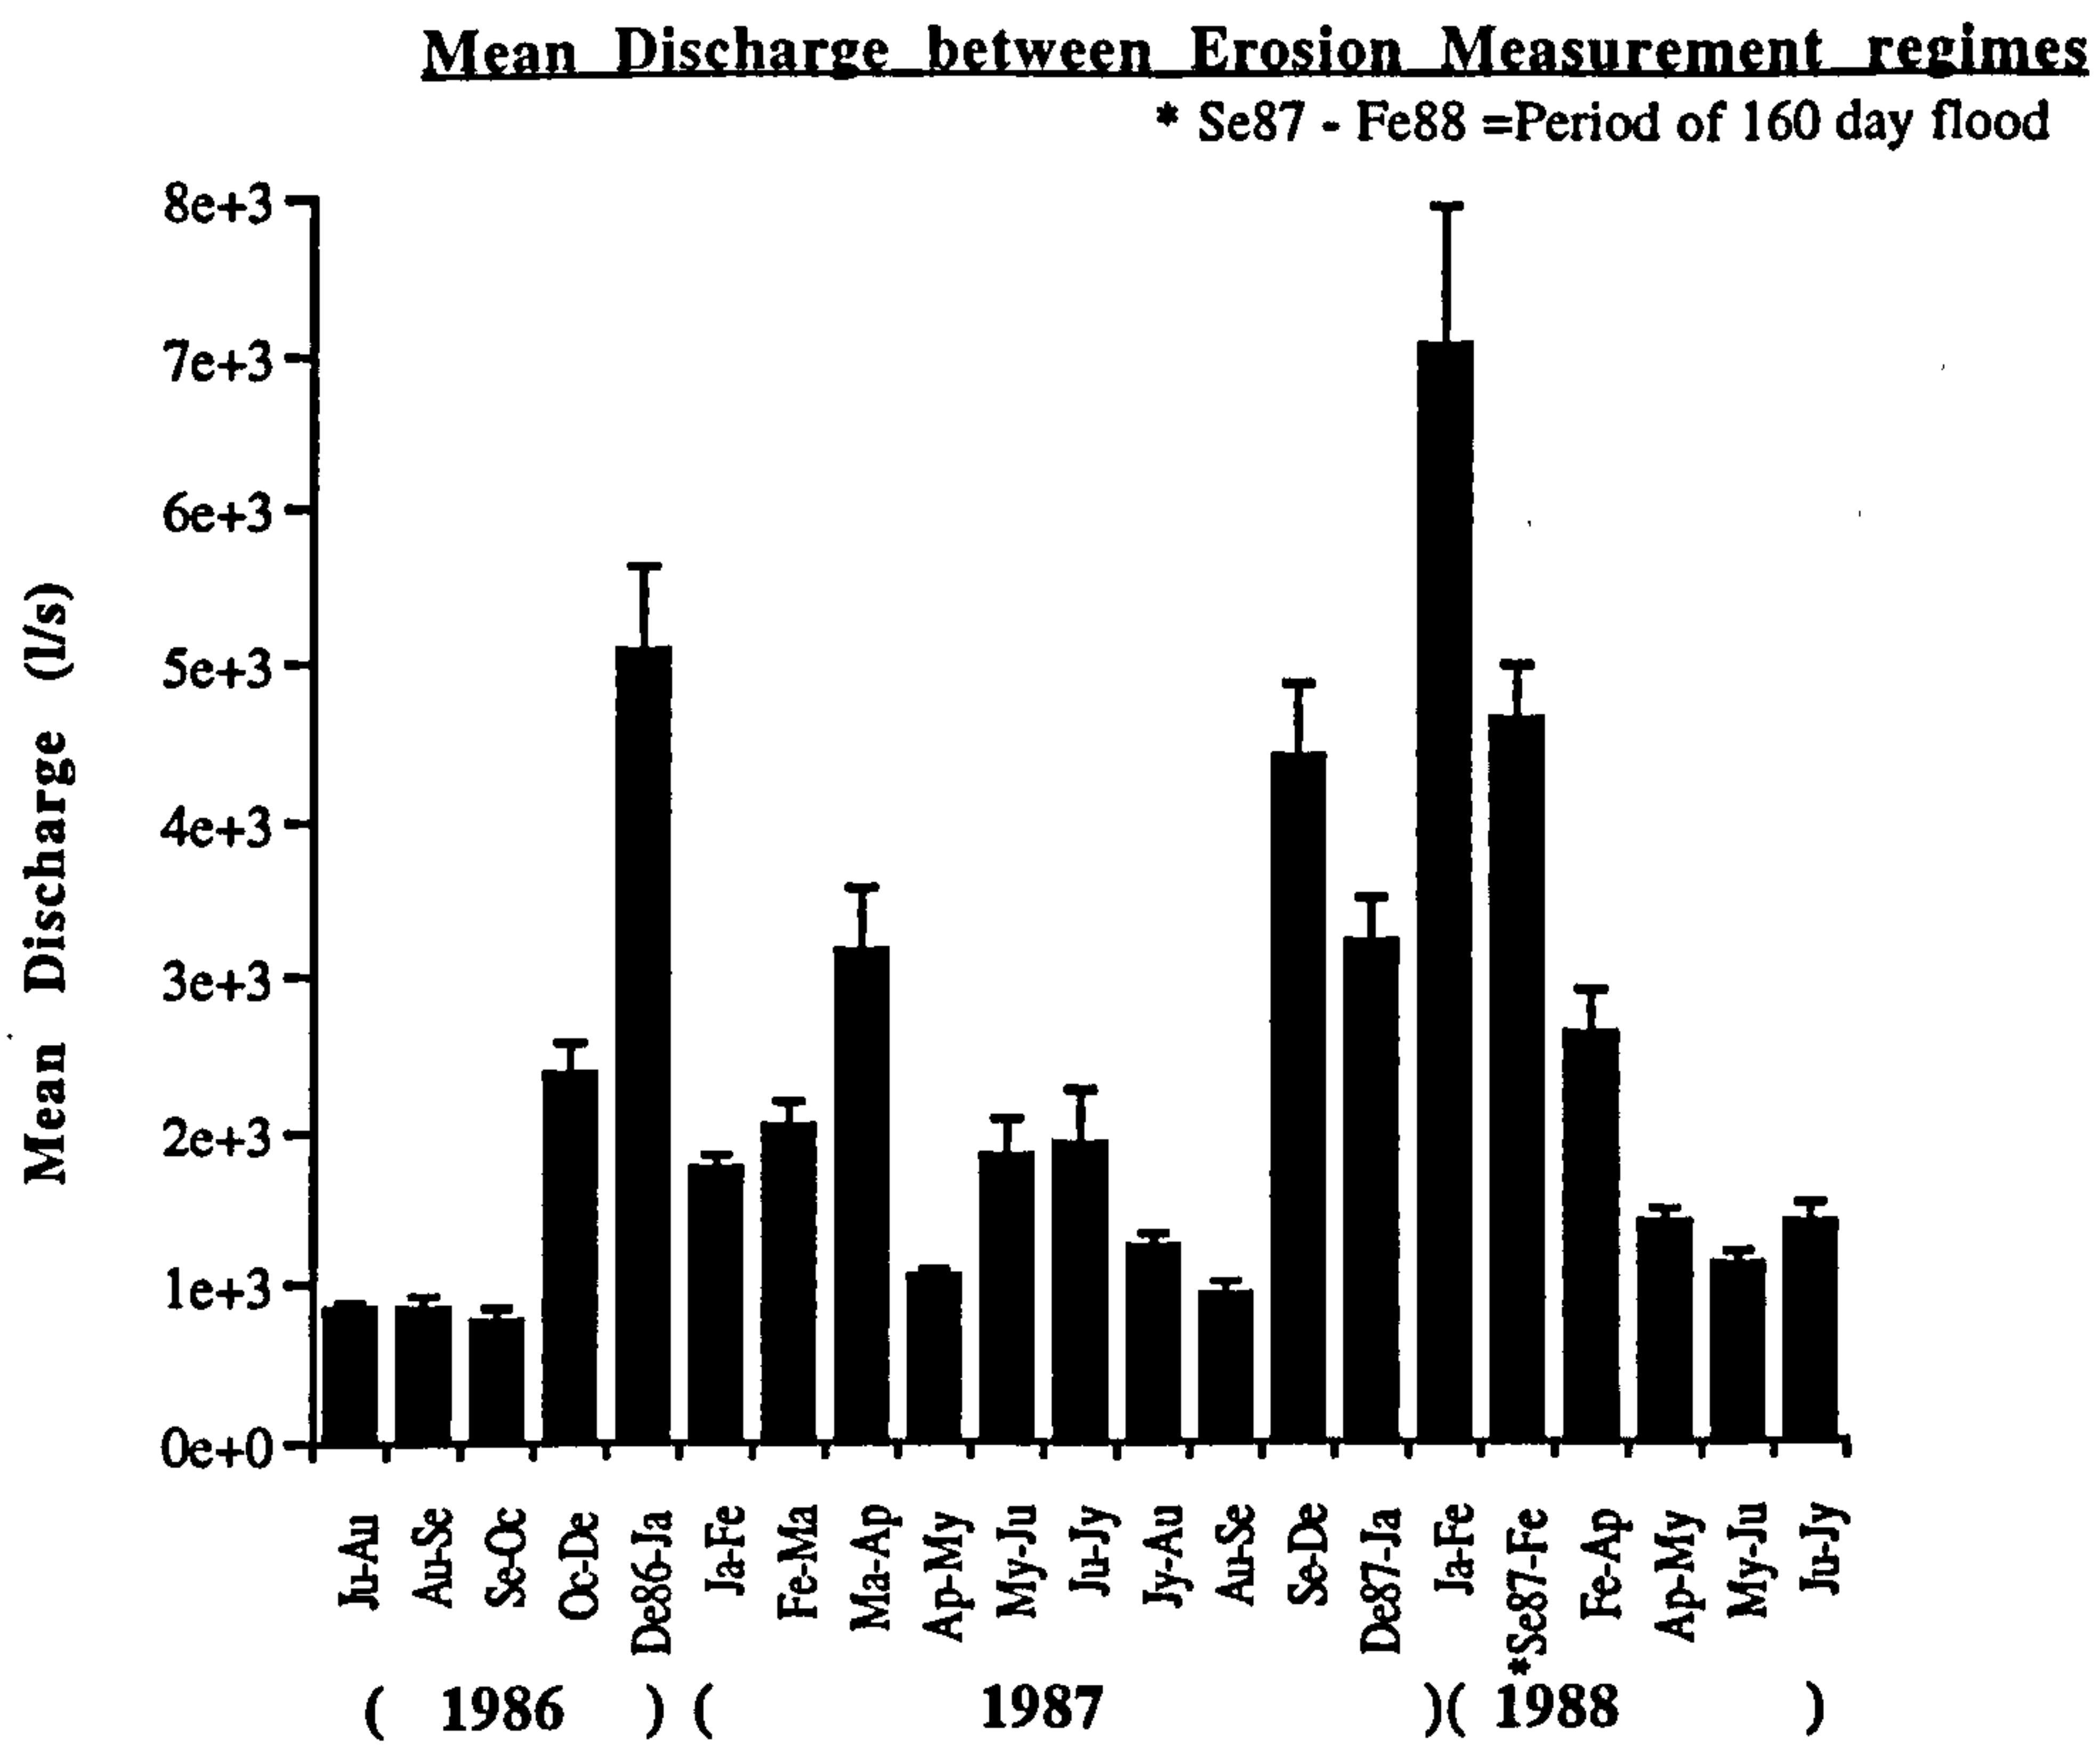
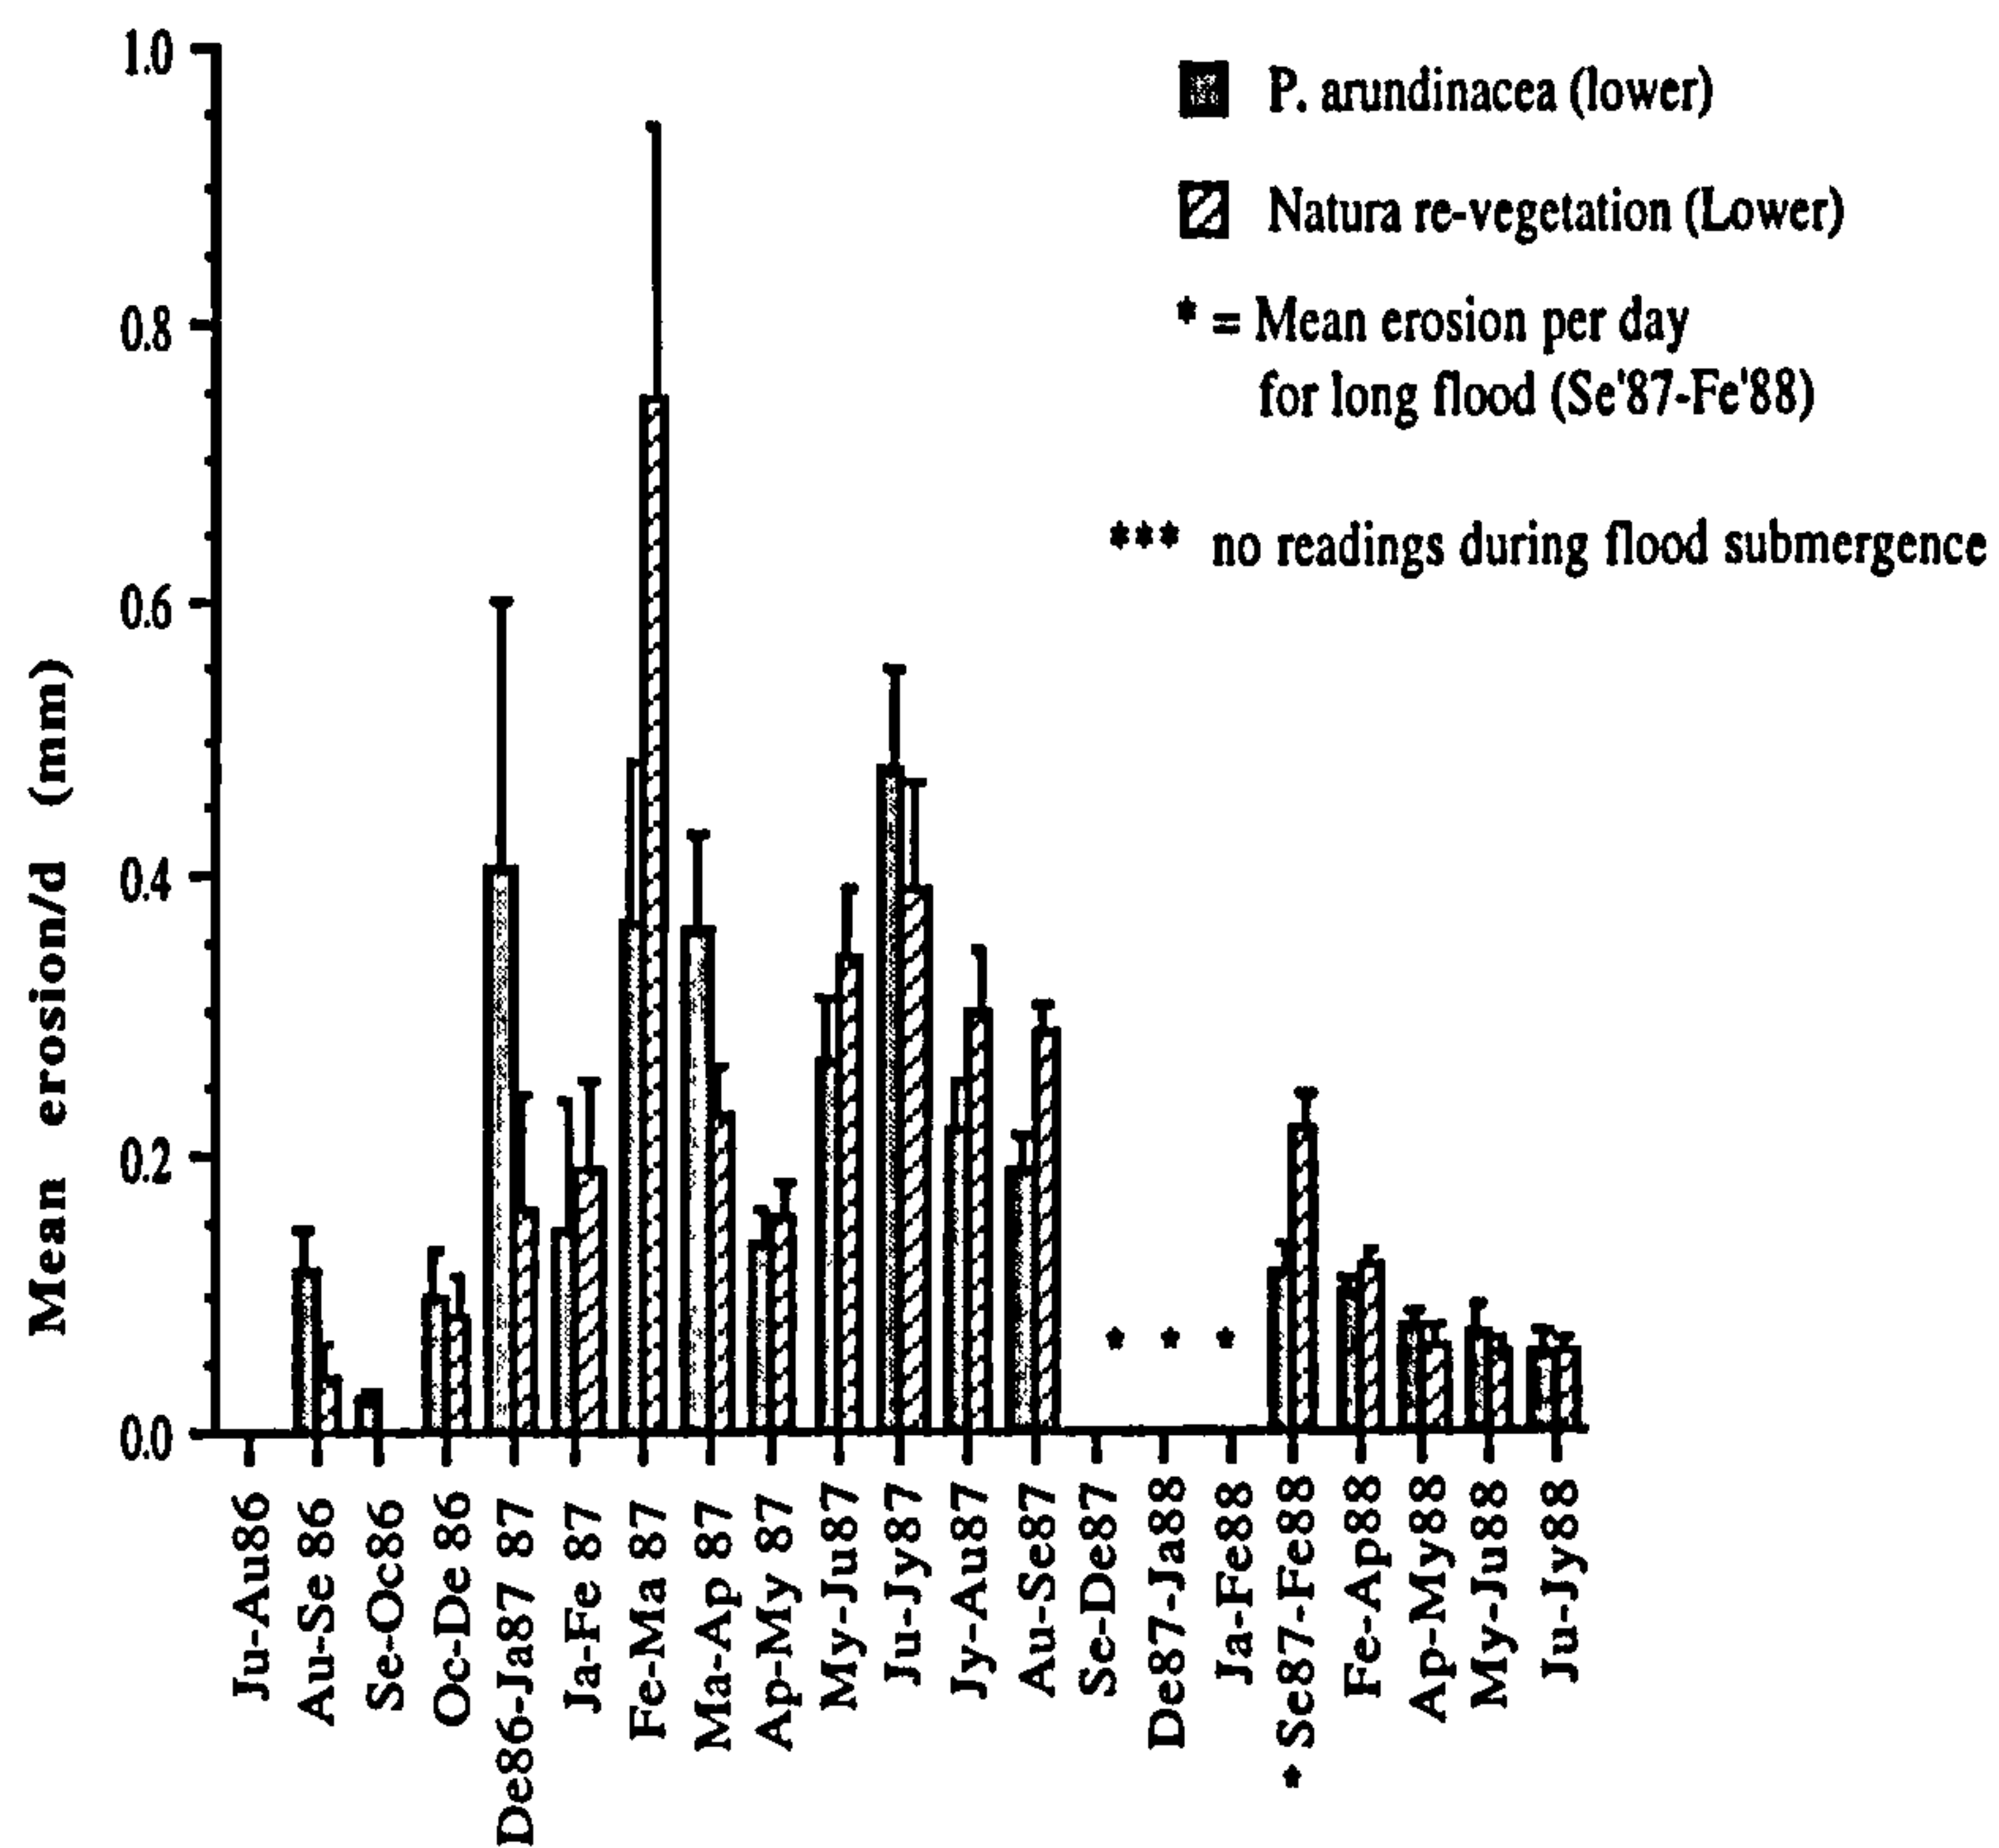
Fig. 5.10 : Comparison of erosion : *P. arundinacea* Vs, Naturally re-vegetated banks (lower banks)
